FORM B – BUILDING

Address 114 East St.

Historic Name Adam Peters House

BUILDING FORM

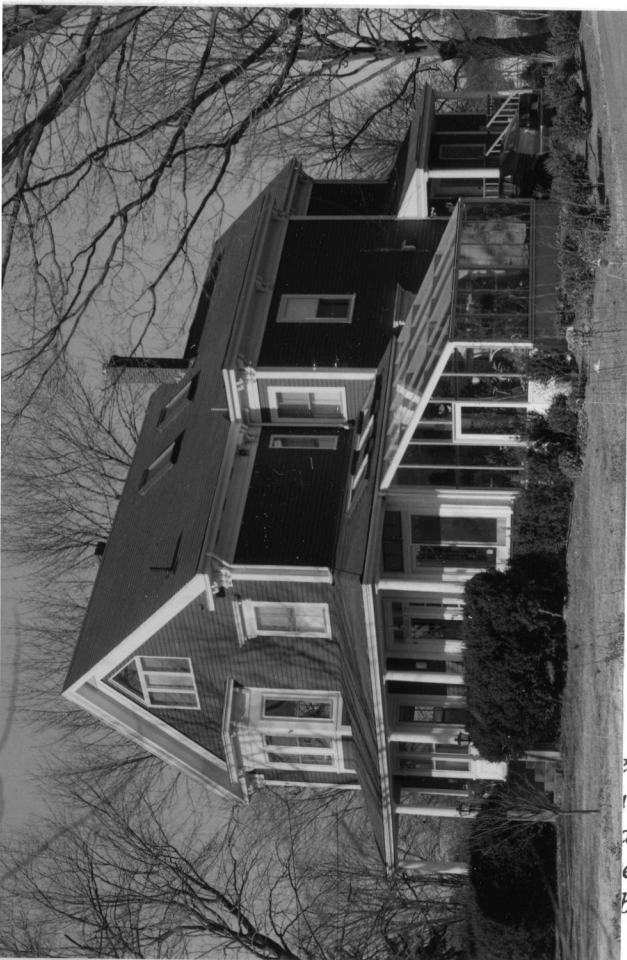
114 East St. (MHC #714) is a nice example of a front-gabled Italianate farmhouse that still has its associated barn and, despite some alterations, still retains many of its original finishes. The original house is rectangular with a rear ell, 2½ stories, two-by-three bays, and front-gabled with two side chimneys. The rear ell is front-gabled, two stories, and two-by-three bays. The house is set on a brick foundation, clad with wood clapboards, and roofed with asphalt shingles. A greenhouse has been added on the east elevation, a one-story shed-roofed addition at the rear of the ell, and a one-story flat-roofed addition on a concrete foundation on the west elevation. The main block has 2/2 or 1/1 double hung windows and a front entrance with a transom light and one sidelight, the other sidelight having been replaced with an engaged Tuscan column. Italianate finishes on the main block include three-sided bays on the facade and both side elevations, paired decorative brackets at the cornice, brackets under the projecting surround of the front second-story window, panels under the bay windows, and a wide eave board in the front gable. A porch with Tuscan columns extends across the facade and Tuscan columns also support the gabled roof over the side entrance of the rear ell. The 1½-story front-gabled barn (MHC #715) is on a brick foundation and has been converted to a studio. A garden shed at the rear of the property has a tall chimney and one open bay for a vehicle.
